NDT Methods for Evaluating FRP-Concrete Bond Performance

Kenneth C. Crawford

The long-term bond performance, 15+ years, of FRP-structural systems applied to reinforced-concrete structures is largely unknown and not widely tested. FRP-structural system performance is a function of FRP-concrete bond condition and is subject to deterioration over time. The purpose of this investigation is to test and validate the non-destructive testing impulse-excitation technique to evaluate bond condition of FRP systems applied to concrete structures, in particular concrete highway bridges. The objective is to identify changes in the FRP-concrete bond state by analyzing changes in impulse excitation (impact) frequencies and sinusoid waveforms. Hammer impact tests were performed on two FRP-retrofitted highway bridges in Missouri and a bonded FRP test plate in the laboratory. Signal analysis of recorded impact acoustic emissions was performed on frequencies and waveform damping ratios of bonded and de-bonded FRP material on two bridges and in the lab. The frequencies and sinusoidal waveforms of the bonded and de-bonded FRP material on the bridges had a high degree of correlation to those of the bon

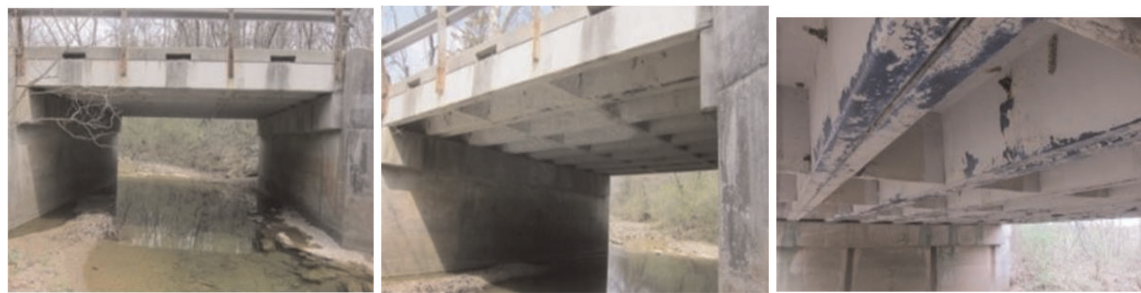
The Creasy Springs Road bridge, **Figure 4**, constructed with precast RC channels like Coats Lane, has the same CFRP plate and fabric configuration on the channel beams as the Coats Lane bridge.

Figure 4.
Creasy Springs Road bridge.

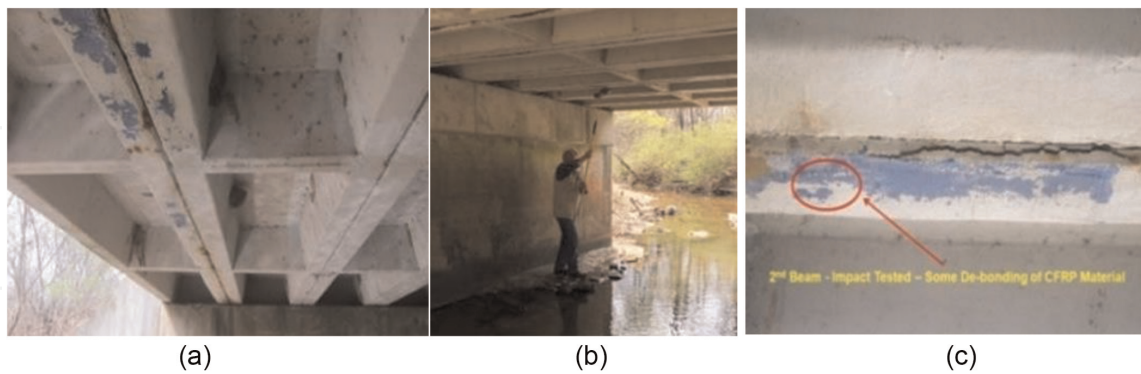
On the Creasy Springs Road bridge impact testing, **Figure 5**, was done on the second beam in the first channel (west side) and then on the third, fourth and sixth beams as far as the extension pole could reach over the water. It is noted CFRP de-bonding was found on the second beam, **Figure 5c**.

Figure 5.
Creasy Springs Road bridge—impact testing on channel beams. (a) Second and third beams, (b) testing fourth beam, and (c) CFRP de-bonding second beam.

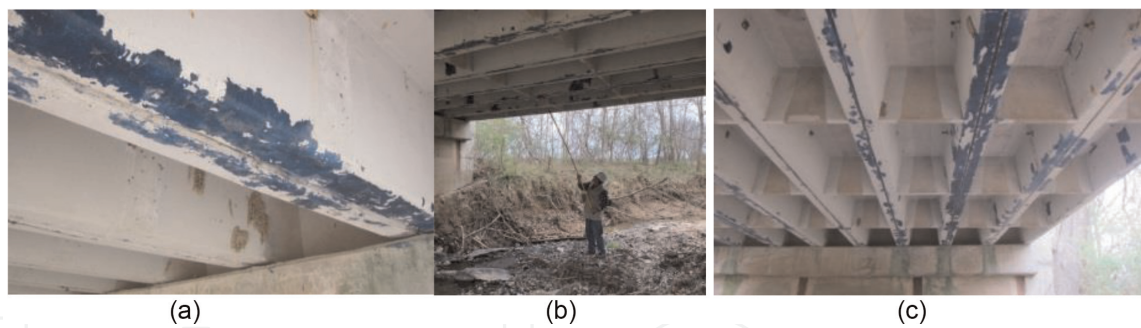
Figure 7.
Coats Lane bridge—testing channel beams. (a) Second beam, first channel, (b) impact testing, (c) beams 6–8.
